# Technical Note

## TN26: Splicing issues encountered when using bend insensitive fibre

**Author:** Paul Cave - Technical Manager

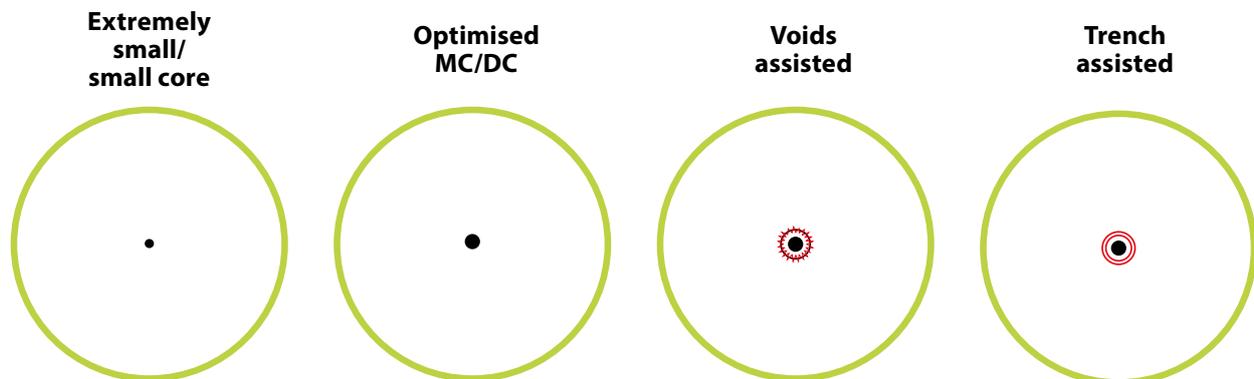
The five primary types are 'Extremely Small Core', 'Small Core', 'Optimised Matched/Depressed Cladding', 'Voids Assisted' and the most common, 'Trench Assisted'

The first two have a very low Mode Field Diameter (MFD) of between 6 and 8.5  $\mu\text{m}$ ; they are not popular due to potential high splice losses. The performance enhancement provided by Optimised Matched/Depressed Cladding is only very marginal so rarely encountered. 'Voids Assisted' It is difficult for 'Voids Assisted' to have good performance, therefore it is costly to manufacture in comparison to 'Trench Assisted'.

The trench, or moat as some people call it, surrounds the core in both Bend Insensitive Singlemode and Multimode fibre to reflect lost light back into the core. The trench is an annular ring of lower index glass surrounding the core with very carefully designed geometry to maximize the effect.

These machines have become confused by the 'trench', leading to them believing the core is bigger than it actually is, which means that they are not able to align the two cores correctly leading to faults being reported and high splice losses.
